## 1.0 INTRODUCTION

## 2.0 THE NEED FOR FORENSIC STUDIES

In this chapter some case studies of failure are presented. In each case study, the possible learning points, technical aspects and ethical implications are also discussed.

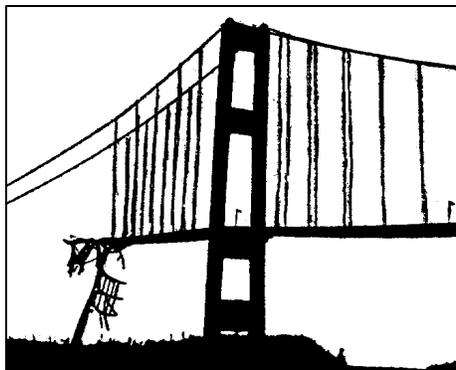
*Fig. 1: Tacoma Narrows Bridge*

In 1940, Tacoma Narrows Bridge was opened across Tacoma Narrows in Washington State. On Nov 7, 1940, with a wind speed of about 60 km/h (well below the design wind speed), the bridge began twisting and oscillating violently. As a result the tie down cables intended to stiffen the bridge snapped, causing the entire structure to crash into the river below.

Investigations (subsequent to the collapse) showed that the excessive vertical and torsional oscillations (which occurred prior to failure) were the result of extraordinary degree of flexibility of the structure and its relatively small capacity to absorb the dynamic forces. The deck was too narrow for the span and thus its torsional rigidity was inadequate. The plate girders, which were provided for stiffening, had insufficient flexural rigidity and little torsional rigidity. Their elevation caused wind vortices above and below the deck in moderate and steady winds. From the day bridge was opened very substantial horizontal and vertical movements of the deck in waveforms were noticeable even in moderate wind and high traffic.

The failure was indeed caused by a lack of proper understanding of aerodynamic forces and knowledge of torsional rigidity in the whole profession. It was not realised by the designers that the aerodynamic forces (which had proven disastrous in the past to much higher and shorter flexible suspension bridges) would affect a structure of such magnitude as the Tacoma Narrows Bridge, despite the fact that its flexibility was greatly in excess of that of any other long span suspension bridge.

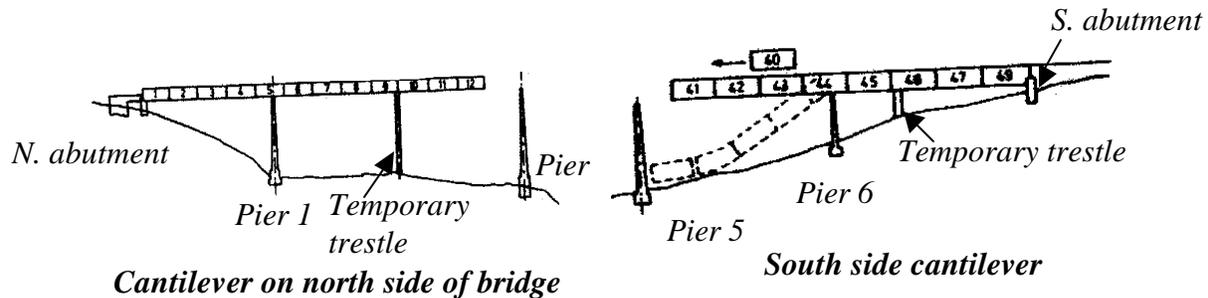
**Fig. 2: Failure of Milford Haven Bridge**

On 2 June 1970, Cleddau Bridge in Milford Haven failed during its erection by cantilevering segments of the span, out from the piers. The bridge was designed as a single continuous box girder of welded steel. The span that collapsed was the second one on the south side. The boxes were fabricated in sections and moved over the previously built sections, aligned in place and welded. The collapse occurred when the last section of box for the second span was being moved out along the cantilever. This section slid forward down the cantilever buckled, at the support and collapsed into the river (Fig 2), killing four men, including the site-engineer.

Investigation of collapse showed that the collapse was due to the buckling of the diaphragm at the support (i.e., at the root of the second span being erected). The diaphragm was torn away from the sloping web near the bottom. This caused reduction in the lever arm between flanges resisting negative bending moment at the support. The tendency of the bottom flange to buckle was inevitably increased by the reduction of the distance between the flanges, as this increased the force needed in each flange to carry the moment with the reduced lever arm.

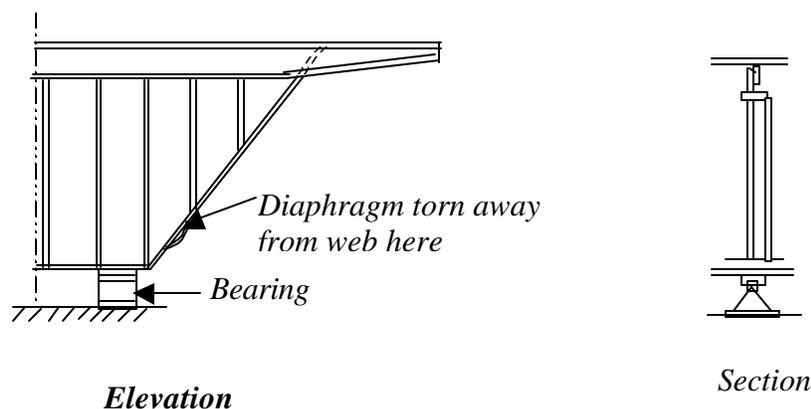
**Fig. 3: Diaphragm over Pier 6 of Milford Haven Bridge**

The support diaphragm was, in effect, a transverse plate girder, which carried heavy loads from the webs of the plate girder at its extreme ends and was supported by the bearings as shown in Fig 3. It was therefore subjected to a hogging bending moment and a large vertical shear force. The shear of the transverse girder and diffusion of the point load from the bearings were compounded with the effects of inclination of the webs of the main bridge girder. These produced an additional horizontal compression and out-of-plane bending effects caused by bearing eccentricity.

The total load transmitted by the diaphragm to the bearings just before collapse was computed as  $9700\text{ kN}$ . This load would not have caused any problem provided the diaphragm was designed to carry it. Allowing for likely values of distortion and residual stress, the calculated design strength, using design rules that were drafted subsequently, was found to be as low as  $5000\text{ kN}$ . Thus, the failure was essentially due to design inadequacy.

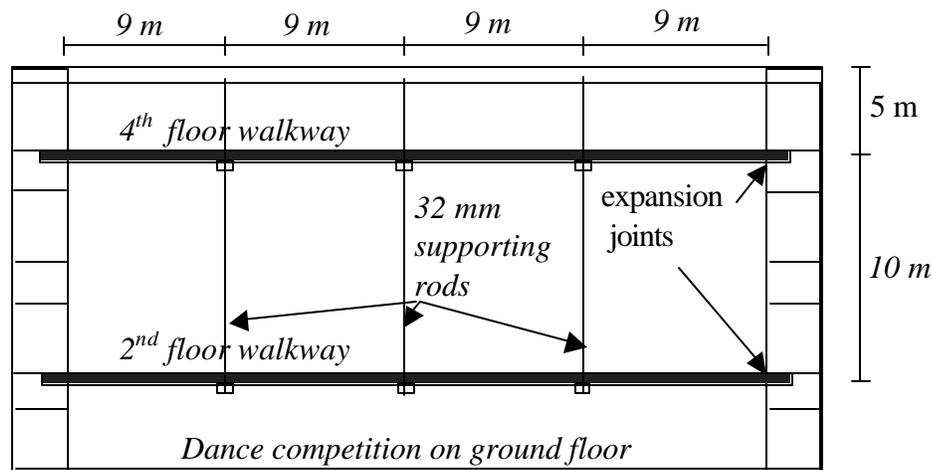
**Fig. 4: Kansas City Hyatt Hotel: arrangement of walkways**

On 7<sup>th</sup> July 1981, a dance was being held in the lobby of the Hyatt Regency Hotel, Kansas City. As spectators gathered on suspended walkways above the dance floor, the support gave way and the upper walkway fell on the lower walkway, and the two fell onto the crowded dance floor, killing 114 people and injuring over 200.

The two walkways were supported above one another and suspended from the ceiling by hanger rods as shown in Fig. 4. The walkways were supported on box beams, which were made of two steel channels, welded together.

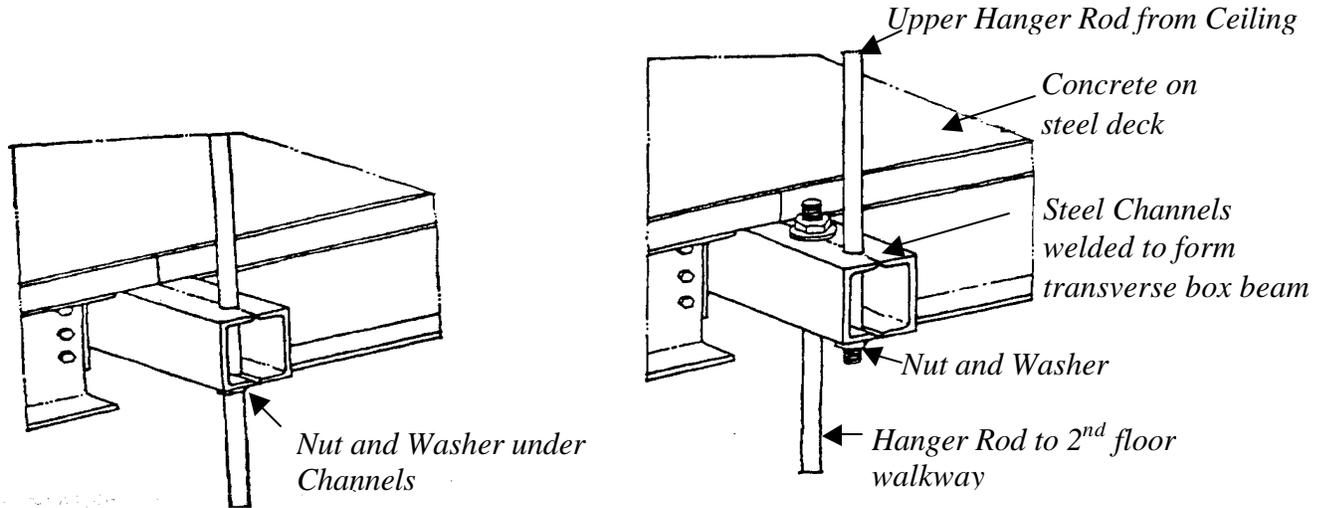
In the original design a single rod supported the two walkways as shown in Fig. 5(a). But the originally designed hanger detail for the two walkways was altered at the time of fabrication as shown in Fig. 5(b). The second floor walkway was suspended from the fourth one as shown. As a result, the connection between the fourth floor cross beam and

**Fig. 5(a): Hyatt Regency Hanger Details As-Designed**

**Fig. 5(b): Hyatt Regency Hanger Details As-Built**

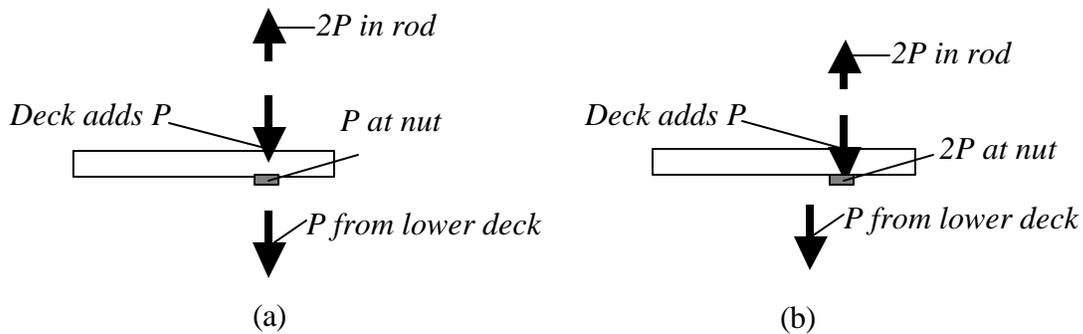
**Fig. 6: Free-Body Diagram (a) As Designed (b) As Built**

the hanger supported double the load originally intended as shown in Fig 6(b). Examination of the box beams supporting the upper walkway after the collapse showed that the upper hanger rod had pulled through the beam. The beam design was also unsatisfactory, and this condition was aggravated by the increased load on the nut. The nut pulled through the box beam as shown in Fig. 7.

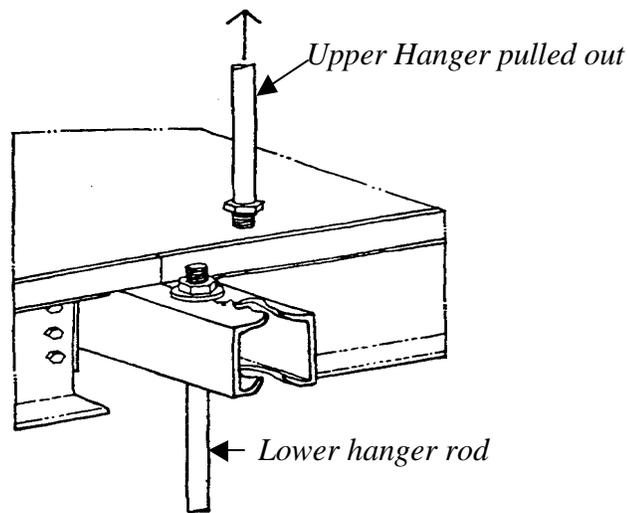
**Fig. 7: Pulled -Out Rod at Fourth-Floor Box Beam**

After the investigations, it was found that the steel fabricator who built the hanger detail requested a change in detail from the originally designed detail. The engineer approved it without checking the calculations. This accident occurred due to the carelessness of the engineer concerned as he failed to understand the importance of the details he had changed. It also illustrates the importance of understanding the force flow in the joints and that of what is often considered as minor detail.

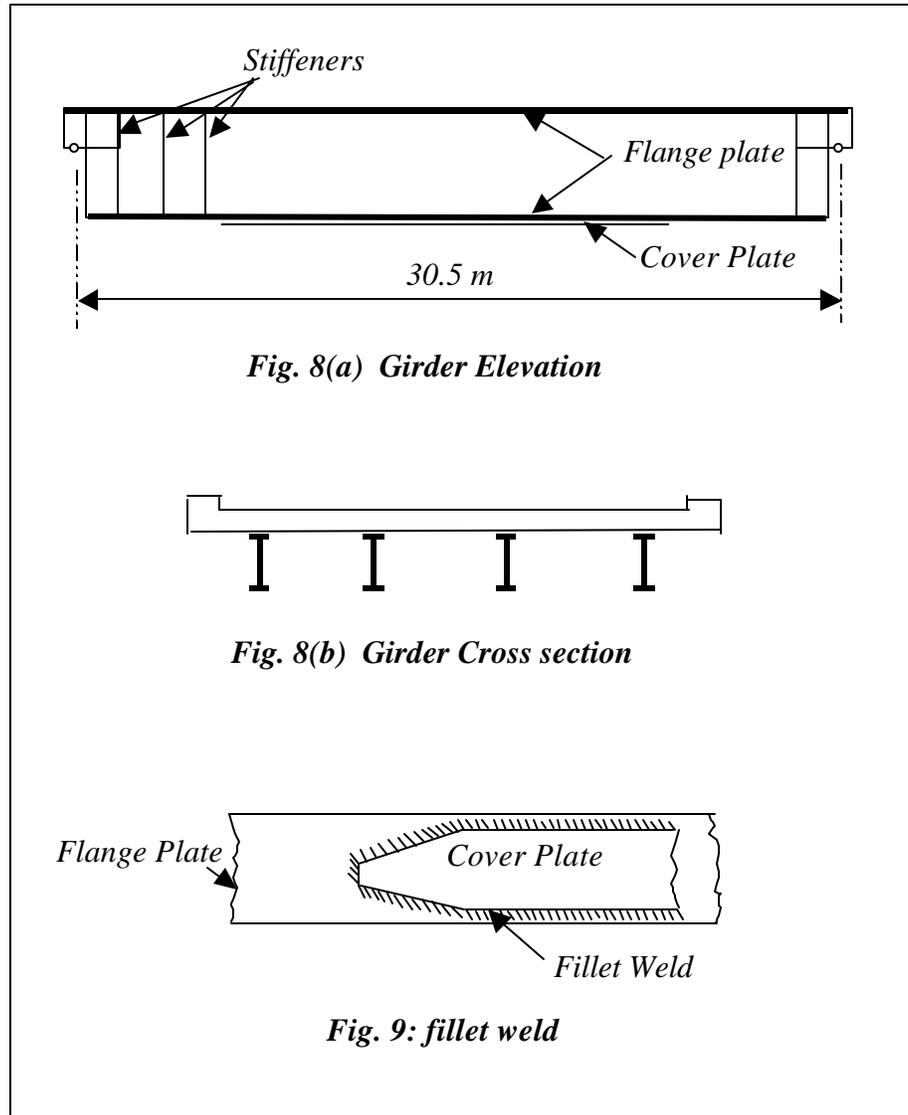
An investigation into the possible cause of failure indicated that the failure was due to brittle fracture and many other spans of the bridge were in danger of similar failure. Cracks were found in the main tension flange plate of the affected span under seven of the eight transverse fillet welds. One crack had extended such that tension flange was completely severed, and the crack had extended halfway up the web.

transverse welds were made in three stages. In some instances cracks were caused in the main flange plate by the first run and later covered up by a subsequent one. In many other cases a crack was caused by the last run and later covered up by priming paint before the girders left the factory. The penetration of later paint coats into the cracks showed that they had often extended further before the bridge was opened for traffic.

The results of investigations clearly indicated that, the failure of King's Bridge was due to carelessness of those who fabricated the girders as well as those who inspected the bridge. It was also found that the most likely and most dangerous cracks were regularly missed by inspectors, who had carefully got the less harmful longitudinal cracks cut out and repaired.

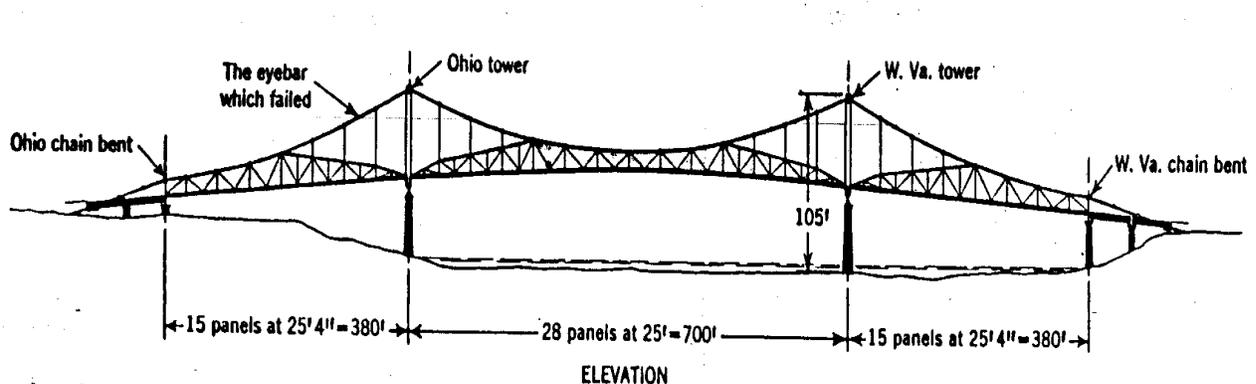
*Fig. 10 a: Silver Bridge at Point Pleasant*

On Dec 15, 1967 Silver Bridge, considered to be first eyebar suspension bridge in the United States, collapsed without warning into the Ohio River. The bridge was spanning Ohio River between Point Pleasant, West Virginia, and Gallipolis, Ohio. The collapse occurred when the bridge was crowded with heavy traffic resulting in the loss of 46 lives and nine injuries.

A thorough investigation revealed that the collapse of the bridge was caused by the failure of the eyebar at the first panel point west of Ohio tower as shown in Fig. 10.

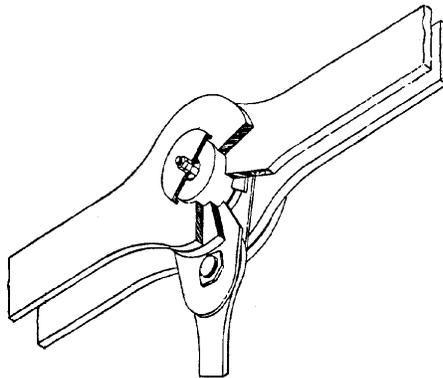
***Fig. 10 b: Detail of Eyebar Chain Joint***

Another undesirable feature of the design was that the eye, where the pin fits, was elongated 3 mm in a horizontal direction for ease of erection. This detail created an air space where corrosion could develop undetected and unabated. The inspection or lubrication of the inside of the head of the eyebar in the Silver Bridge was impossible without dismantling the joint

Thus the combination of high tensile stresses and corrosion caused a crack on the inside of the eyebar, under the pin at a location of a manufacturing flaw about  $6\text{ mm}$  in size.

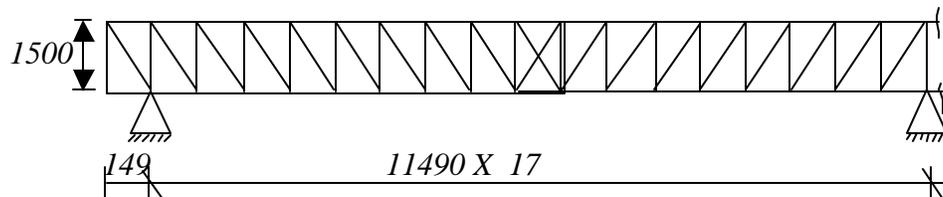
*Fig. 11: Elevation of Truss*

The case study concerns a factory building near Nellore, India. The building was of size  $25.7\text{ m} \times 52.5\text{ m}$ . The roof was made up of steel Pratt trusses supported on concrete columns. The entire truss was exposed except for the bottom chord members, which were embedded in concrete slab.

After curing the concrete slab, when the scaffoldings were removed, the deflection of the roof was found to be  $100\text{ mm}$  ( $>L/325$ ). In order to find out the cause of these disproportionate deflections, the truss was reanalysed. The configuration of the truss is shown in Fig. 11. From the analysis, it was found that most of the members of the roof truss were not safe. After performing several analyses, it was concluded that in the original design, the designer might have miscalculated the loads. In India, industrial buildings were normally covered by asbestos cement sheetings. Hence the original designer of the truss, due to his inexperience, might have considered the truss to support Asbestos sheeting, instead of heavier concrete slab. The analysis considering only AC sheet roofing confirmed that all the members of the roof would be safe for the reduced loading.

building. Hence the repair of the roof had to be done without affecting the work of installing these machineries. Hence it was decided to strengthen the top and bottom flanges of the top chord members by welding extra plates on them. It was also decided to weld angles inside the web members of the truss. Since the bottom chord member was inside the concrete slab, it was not possible to add anything to the bottom chords.

It was also recommended to provide temporary supports to the truss at  $1/3$  point for welding extra plates and angles. But the contractor did not provide the temporary supports and welded the extra plates and angles. This resulted in the buckling of the web of the top chord members. The web members in one or two trusses had also buckled. Hence after careful consideration it was decided to reduce the span of the truss which would eventually reduce the forces in the members. After consultation with the manager of the plant, the locations of these intermediate columns were fixed and then the work was carried out.

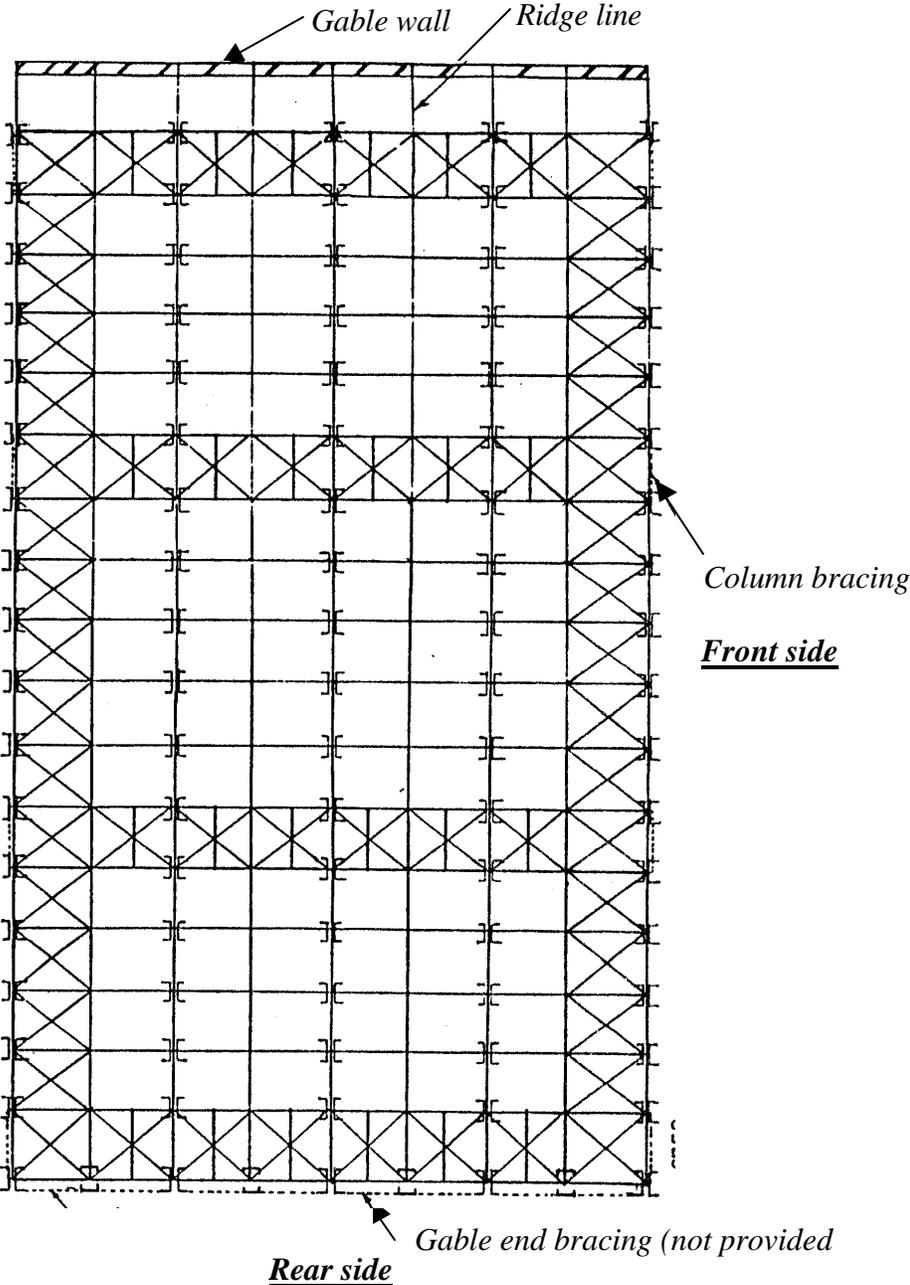
**Fig. 12: Layout plan of the factory building**

In order to understand the failure of the structure, the original design was examined. The main causes of failure were found to be,

- (i) wind loads were not estimated properly as per *IS:875*.
- (ii) column and rafter sections were found to be inadequate to resist the load; they did not even satisfy the main  $l/r$  ratio specified in the Code.
- (iii) during erection, the bracings were not connected properly to the main members.

For the restoration of the structure, the designer was asked to use the same sections and produce a design, which would not increase the cost of the project considerably. Hence same channels were used; but their spacing was altered to form a box section with diagonal bracings of channel section. The span and bay width were kept the same. This arrangement increased the moment of inertia of the section along the frame and perpendicular to the frame. The rigidity of the structure increased considerably in both

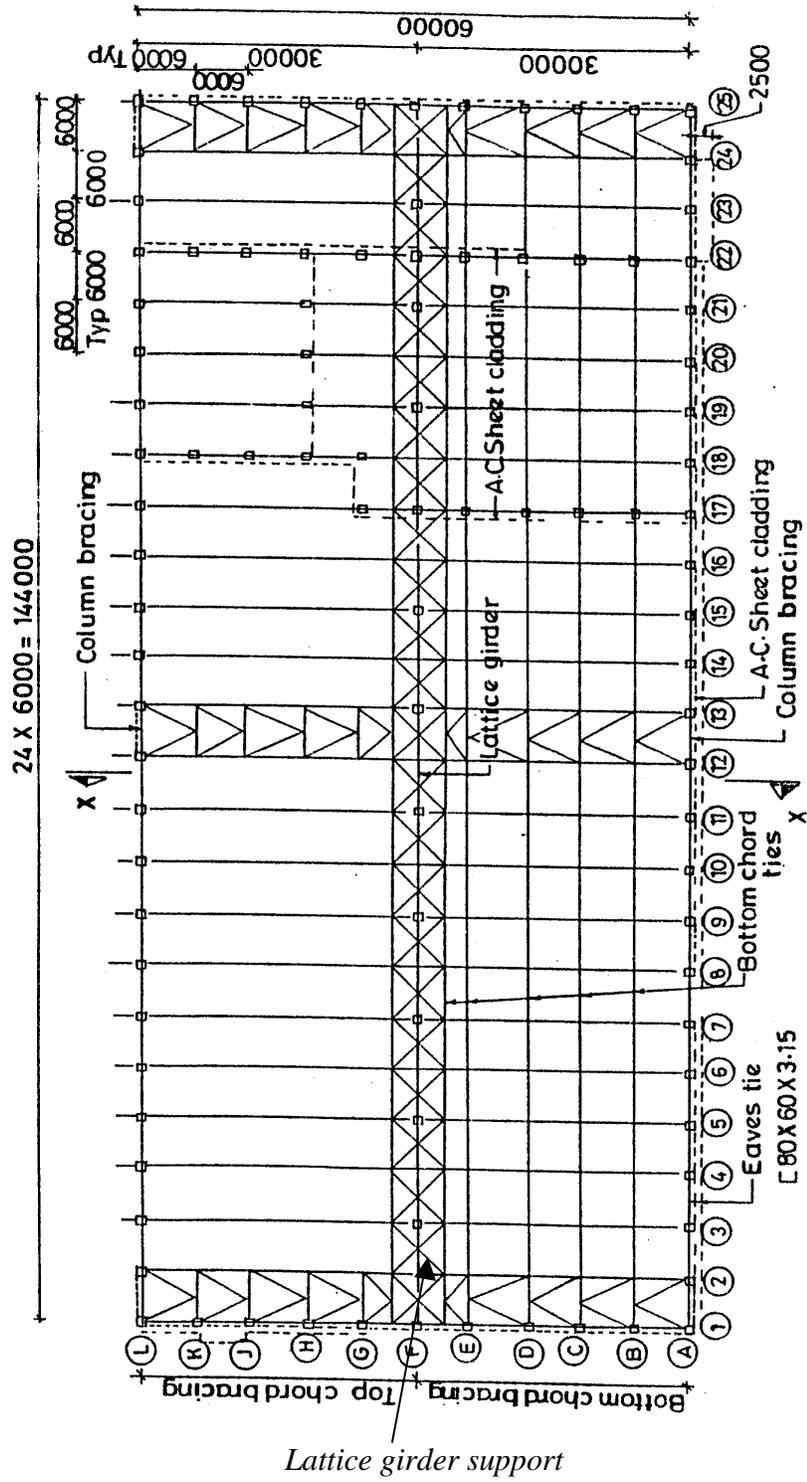
Fig.14: Plan view of the structure

After the erection of portal frames and placing of asbestos sheets, some problems were encountered. The purlins and side cladding girts got twisted. This resulted in the cracking of some AC sheets. Some columns (especially those supporting the partitions) were not straight and gave a buckled column appearance. Most of the side cladding girts were sagging.

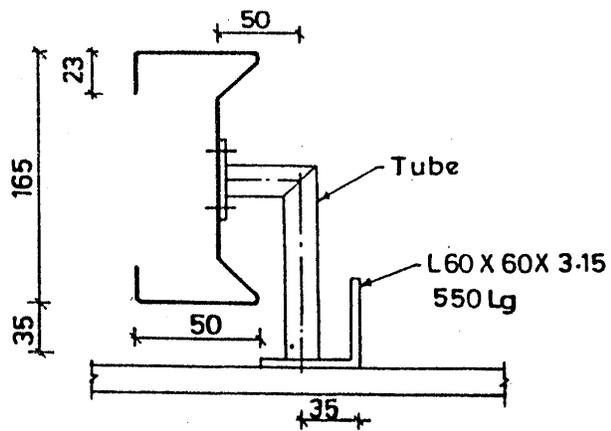
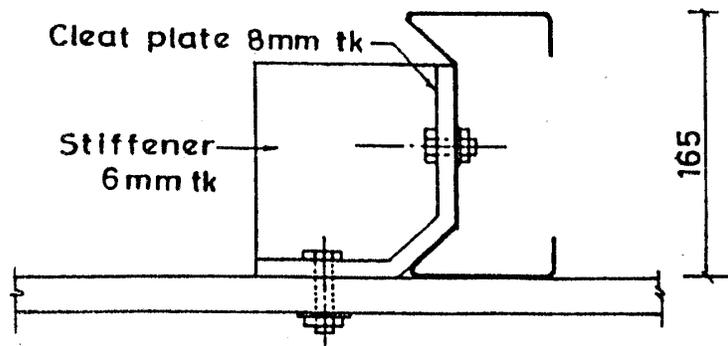
Fig.16: Adopted and correct seating detail of purlin

(a) Connection detail as adopted at site

(b) Correct connection detail
